Memo

Project: Seismic Resilience Assessment

To: Brett Musick, PE, City of Newberg

Subject: Executive Summary

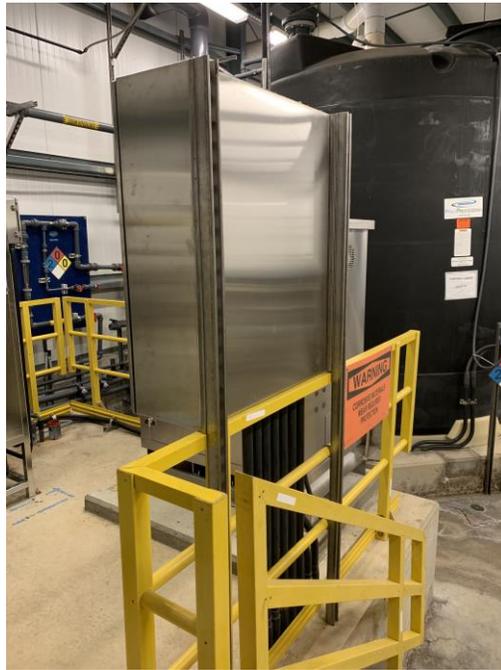
Figure 3.89 – Control Panel not Adequately Braced

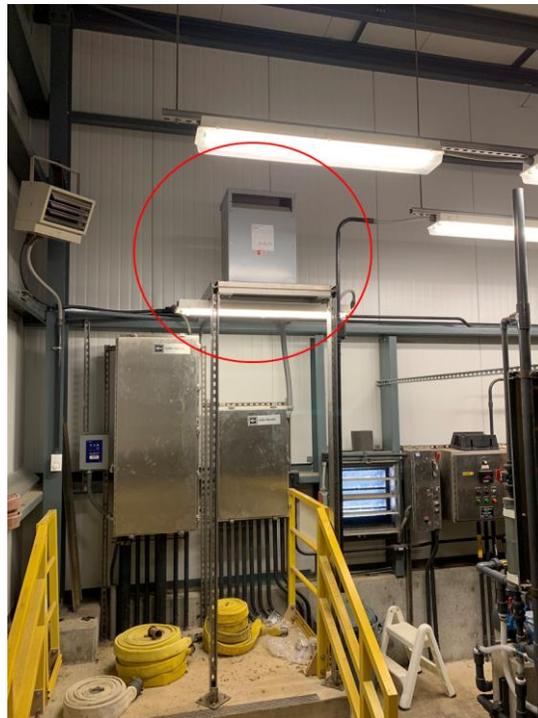
Figure 3.90 – Transformer not Adequately Braced

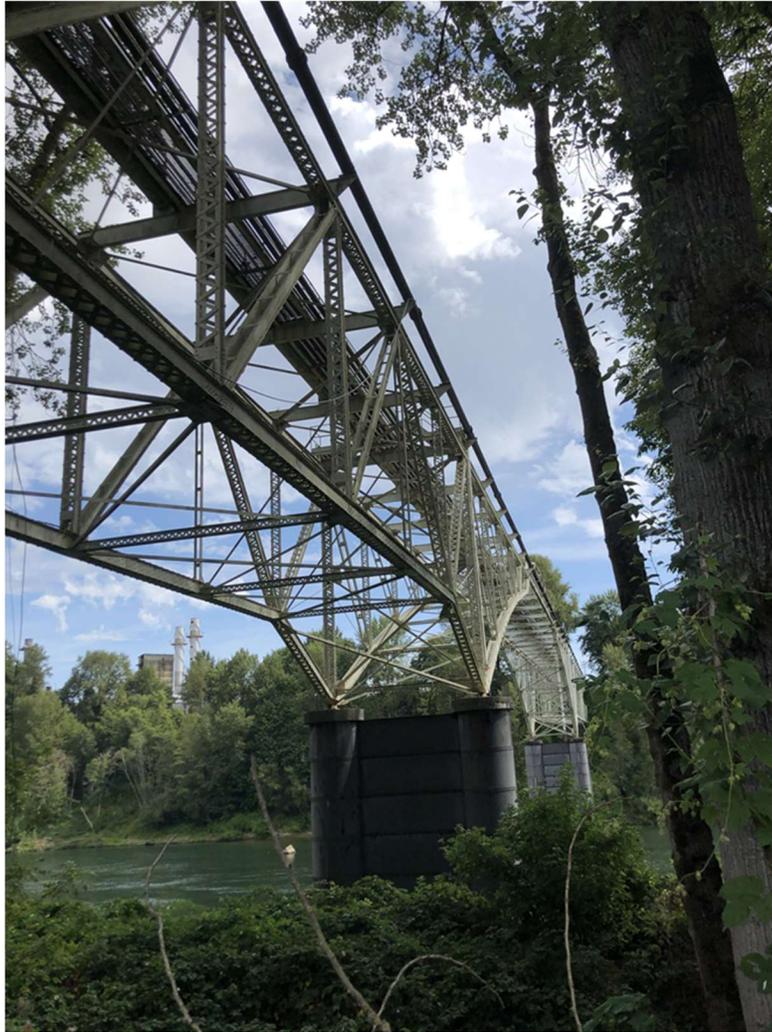
Figure 1. Pipeline Bridge Superstructure

The bridge superstructure (Figure 1) is constructed of a riveted truss with apparent pin bearing assemblies to the substructure. Because the photos do not show the abutments, their condition is unknown. Photos show the middle span bears on the cantilever arms, but the level of restraint is unclear. When the bridge was converted for waterline use, the deck was removed and waterlines and a catwalk installed on the existing floor beams. This helps the seismic performance of the bridge, as it reduces the seismic mass of the structure from its original configuration.

In general, older truss bridges were not designed for ductility and do not perform well in a seismic event. Retrofitting them to ensure ductile behavior is prohibitively expensive in most cases. A common retrofit procedure used with older truss bridges is replacing the bearings with isolation bearings. This method, also known as "base isolation," allows the superstructure to move independently of the substructure, and minimizes the earthquake forces being transmitted to the bridge. On this bridge, the waterline would need to be isolated, which could likely be accomplished by replacing the fixed bearing waterline assemblies with rollers. The truss would need to be checked for seismic forces, as some seismic loads may affect the superstructure. However, any required modifications would likely be less costly than those required if no base isolation was performed.

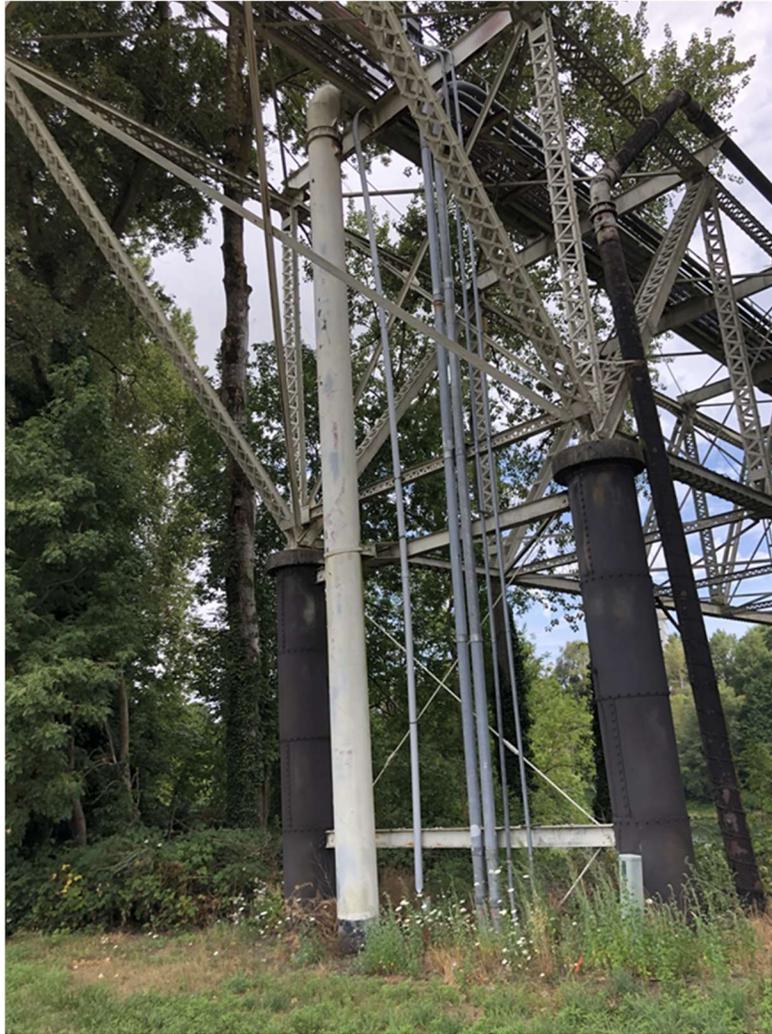
Figure 2. 24-inch Water Transmission Main

The 24-inch ductile iron water transmission is approximately 2,085 linear feet, installed in 1980 (Figure 2). This transmission main parallels and serves the same function as the 30-inch HDPE transmission main, by conveying raw water from the wellfield to the City's WTP. The pipeline shares the bridge deck with other power and communication pipelines/conduits. Because the pipeline is solely supported by the bridge, the pipeline will be subject to any failure modes experienced by the bridge in a seismic event. Isolation valves are located on each side of the bridge, which can provide isolation of the damage. Depending on how the bridge fails, damage to the interconnecting system, water loss, and potential cross-contamination may also occur.

With regard to the 24-inch transmission main, it shares the same structural risks as the bridge. It is unlikely to survive a CSZ magnitude 9.0 seismic event. Because of its low resilience level, the water system is vulnerable to damage to the interconnecting system, water loss, and potential contamination. Isolation valves on either end of the bridge can be closed to minimize water loss if pipeline damage occurs, but they lack automation for quick closure and could be damaged during a CSZ event.

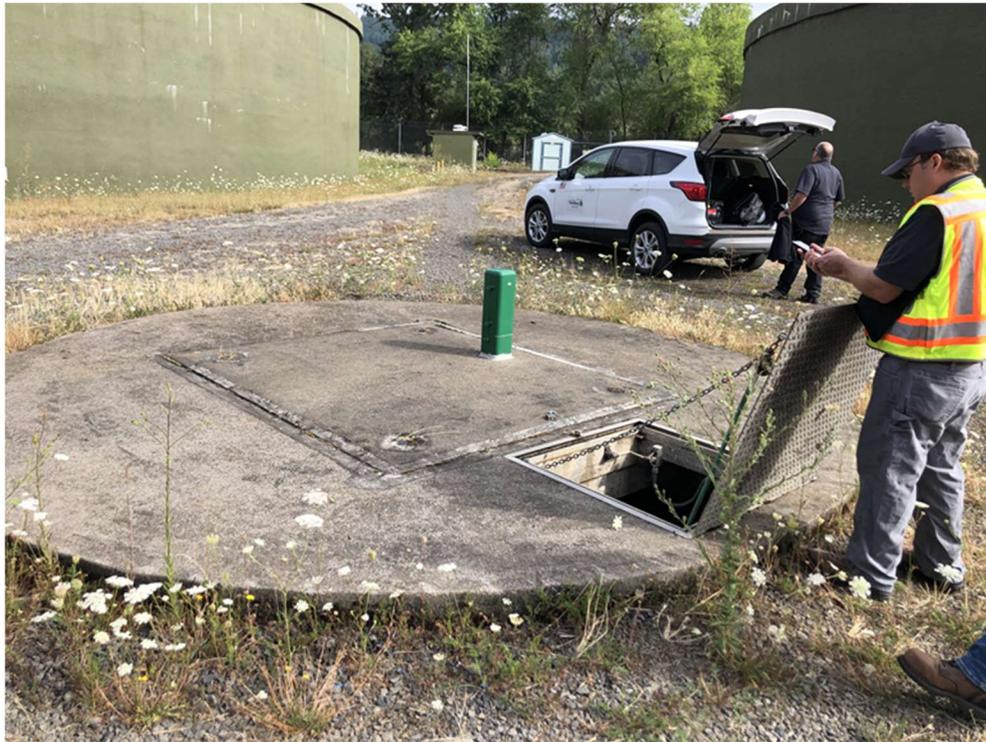
Figure 6. North Valley Site

- This site location (Figure 6) is subject to higher magnitudes of permanent ground deformation. Differential settlement of approximately 0.5 to 1.5 inches could occur between structures and connecting pipelines. It is unknown if exterior couplings could absorb this movement.
- The inlet/outlet line to the site will be subject to landslide movement up to 2 feet. This is a significant range of movement that would require one or more seismic couplings to absorb. In its current state, pipeline separation likely would occur.
- There is a remotely operable isolation valve on the inlet/outlet line to the water tank, allowing for quick isolation and protection of the water storage in the tank during and after an event. There is not, however, a hydraulic control valve, that could operate and close independently of the SCADA system (if down) to protect the water storage.
